Yosemite National Park

National Park Service
U.S. Department of the Interior

Happy Isles Gauging Station Bridge Removal

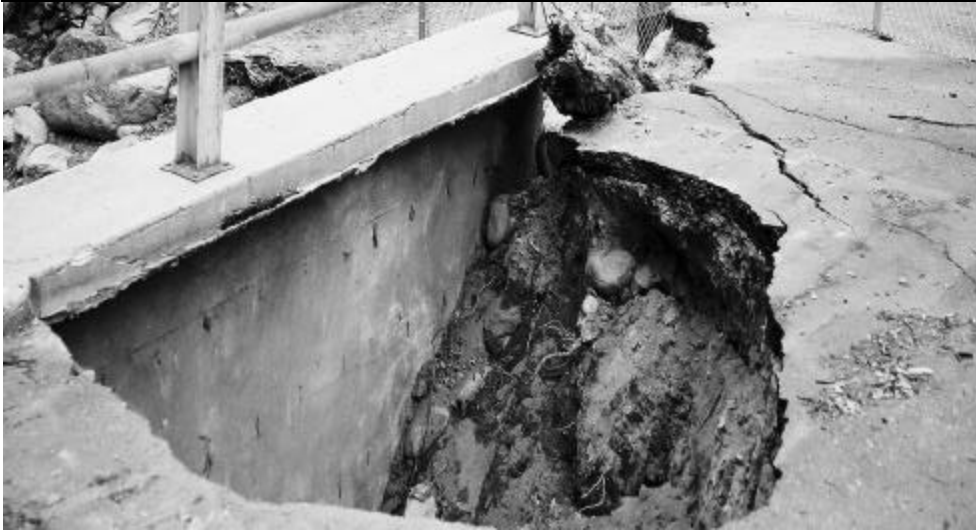
The bridge was badly damaged during the 1997 flood and was deemed unsafe by representatives of the Federal Highway Administration. Based on these findings, it was condemned for safety reasons in July 1997. The bridge continued to deteriorate and began to show signs of immediate failure in 2000 when a large sinkhole appeared on the west abutment (shown above).

The loss of support under the west abutment caused the structure to hang from the west wingwalls, introducing stresses for which the bridge was not designed. The west abutment area was also cracking and crumbling, indicating severe failure and imminent collapse of the structure.

Due to the threat to public health and safety, the bridge was removed in the fall of 2001. The east abutment was retained to protect the operational stream flow gauge.

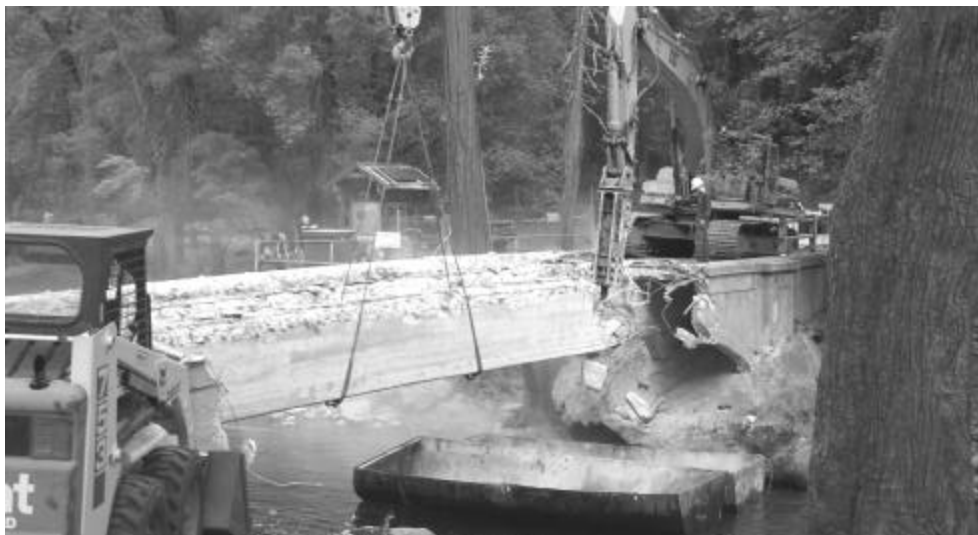
The bridge was removed in the fall of 2001 using a “controlled demolition” method, which included installation of a temporary structural support system to prevent uncontrolled collapse of the bridge structure during demolition. The bridge was then separated into liftable segments which were removed using equipment located on the riverbank (see above). Temporary floating tubs were installed beneath the bridge to prevent slurry from concrete saws, as well as debris, from falling into the Merced River. The river- right abutment, located on a large boulder on the riverbank, was retained to protect the historic Happy Isles Gauging Station. Although the bridge was removed last Fall, landscaping and cleanup are currently ongoing, after being put on hold due to the winter weather conditions. It is anticipated this work will be complete in July of 2002.
